VEHICLE DETAILS

Chassis number ¹: EG2-1200044

Make: HONDA

Model: CR-X DEL SOL

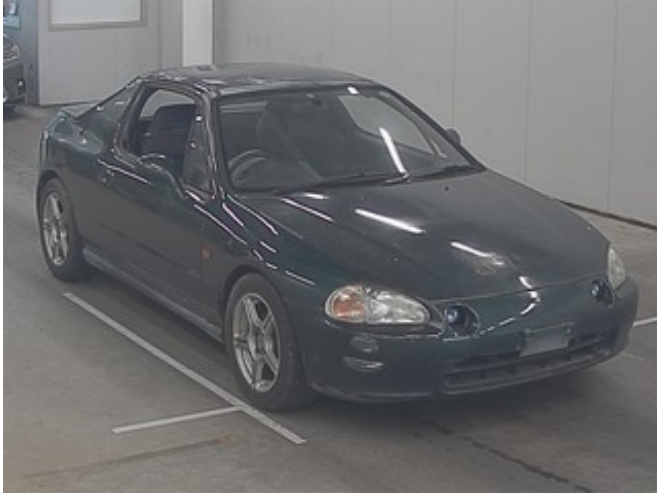
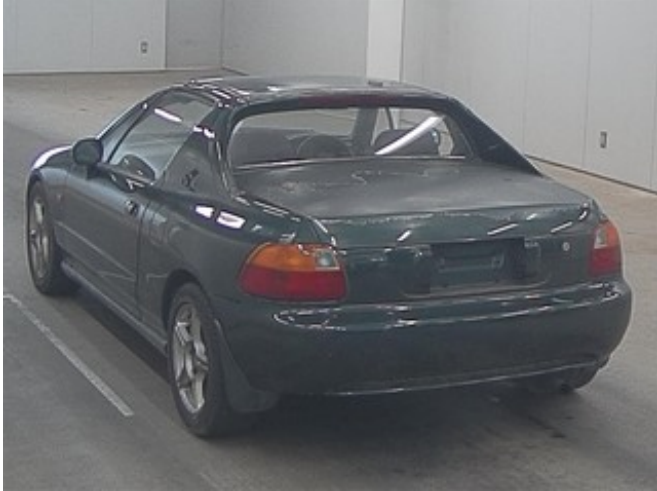
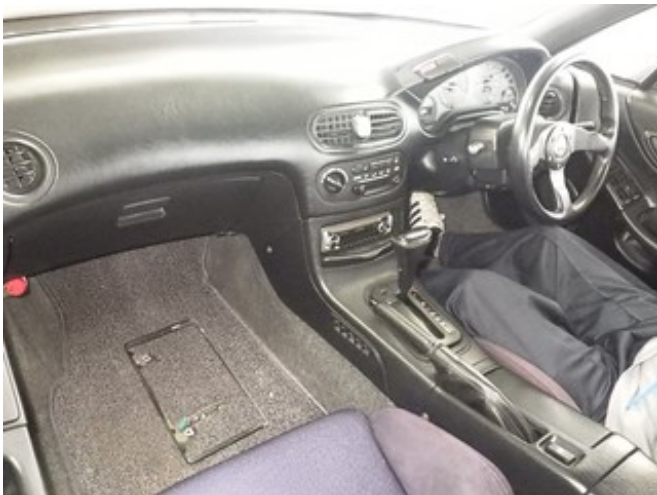
86661	車歴 (自家用以外は記入)		排気量	型式	3
			1600	E-EG2	
初年度登録年月		車名	グレード	2WD	C
6/10月		CR-X デリスOL	2ト	4WD	
車検	年	月	シフト	AT	特選
走行	97,899	Km	冷房	AC	S R 純AW (S) (W)
外色	元色	色種	カラー	社外モンスターリング	カワ TV ナビ エアB
燃料	ガソリン	軽油	内装色	社外ナビ付	
リサイクル料	9080	円	リサイクル料		
注意事項 (傷・不具合箇所および状態等)			登録地		
			車台地		
			シリアル地		
			EG2-1200044

○検査員報告 (USS使用欄)

ハンドルズ トア29-72 P114

内パリアフェイル

内装フェイル

シートズフェイル

オイルレシ 電動ホーン不良

ヘッドライト 外装 P114 (多)

外足廻り? F1201 P17 8220 フェイル
