## VEHICLE DETAILS

**Chassis number <sup>1</sup>:** EF8-1104325

**Make:** HONDA

**Model:** CR-X

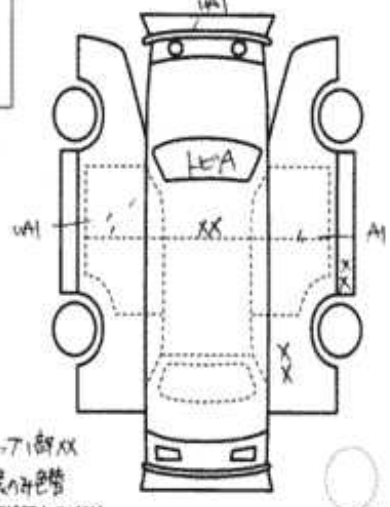
## 検査員報告 (USS使用)

- 電格ミラ不良
- 車内音、ノイズ
- シート破れ
- カーペット
- ハンドレバー
- IL707-BP
- ホイール
- 台内寸計

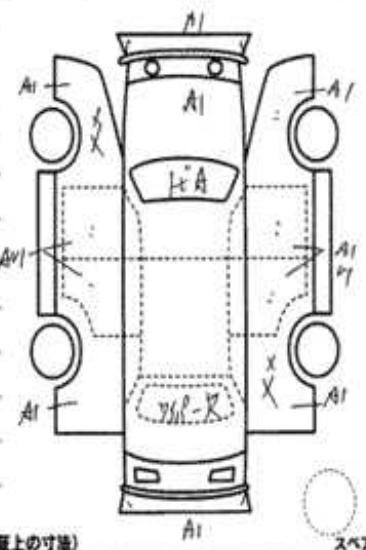
◎検査員報告 (USS使用欄) 智貴

電検不検 不明

AC スイッチの動作確認不

シフトレバーの作動不

天窓の動作確認 不明

AVの動作確認 不明

ナビの動作確認 不明
