# **Vehicle History Report**

Chassis number <sup>1</sup> :	PG6SA-101552	Title information <sup>2</sup> :	<b>,</b> 60	Deregistered to Export	•
Manufacture date:	1992-10		<b>u</b> _		
Make:	MAZDA	Accident / Repair:	Ì₹	Problem found	×
Model:	AUTOZAM AZ-1	Odometer rollback:		No problem	0
Body:	E-PG6SA	Manufacturer	6		
Grade:	AZ-1	recall:		No problem	
Engine:	F6A	Safety grade <sup>3</sup> :	8	No data	⊘
Drive:	MIDSHIP	Contamination			
Transmission:	F5	risk:	<b></b>	No problem

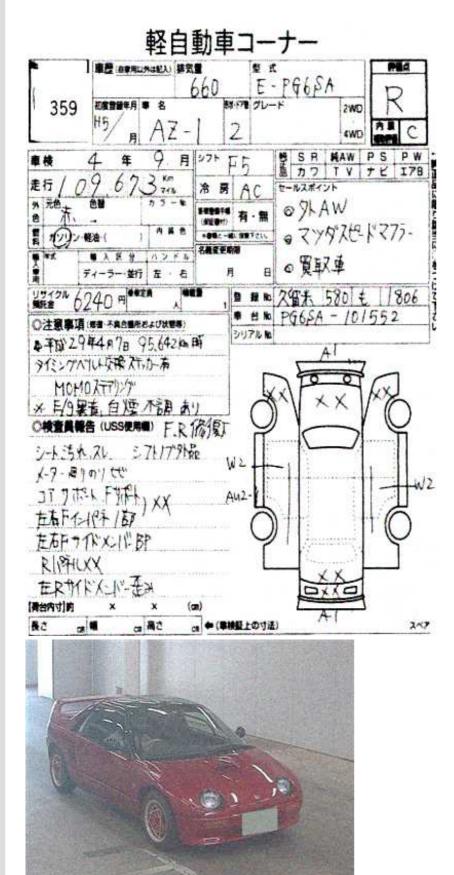
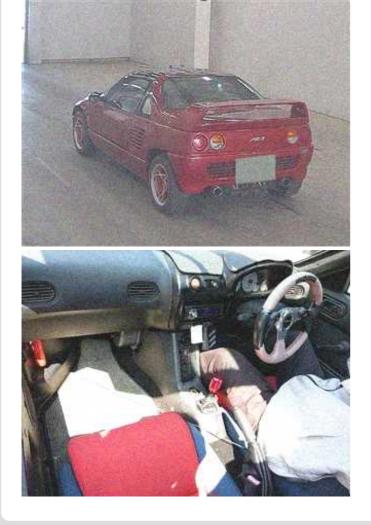
## PHOTOS AND AUCTION SHEETS

Date:	2021-04-08	Lot #:	359
Auction name:	<u>USS Tokyo</u>	Region:	Chiba
Make:	MAZDA	Model:	AUTOZAM AZ-1
Reg. year:	1993	Mileage (km):	109673
Displacement (cc):	660	Transmission:	F5
Color:	RED	Model code:	PG6SA
Result:	available	Auction grade:	R
Problem type:	Collision	Problem scale:	Repaired
Contaminated:	No	Airbag:	ОК
