# **Vehicle History Report**

Manufacture date:			<b>F</b>	Export	
	1994-09		<b>u</b> _		
Make:	ΤΟΥΟΤΑ	Accident / Repair:	Ì₽	Problem found	:
Model:	MARK II	Odometer rollback:		No problem	
Body:	E-JZX90	Manufacturer	~		
Grade:	TOURER V	recall:	9	No problem	
Engine:	1JZ-GTE	Safety grade <sup>3</sup> :	8	No data	(
Drive:	2WD	Contamination			
Transmission:	AT	risk:	Å	No problem

### Date: 2022-01-18, Auction: USS Yokohama, Lot #: 62333

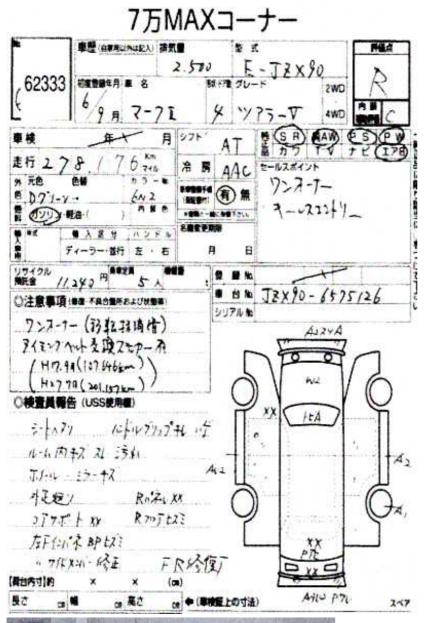
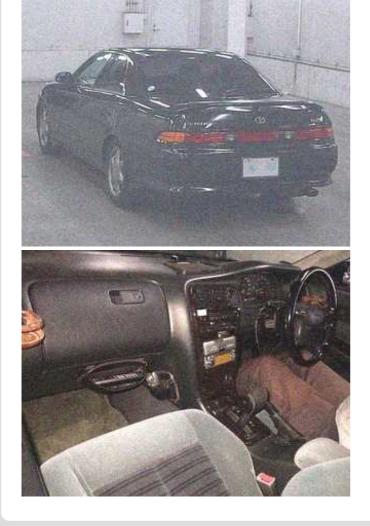
# PHOTOS AND AUCTION SHEETS

Date:	2022-01-18	Lot #:	62333
Auction name:	USS Yokohama	Region:	Kanagawa
Make:	ΤΟΥΟΤΑ	Model:	MARK II
Reg. year:	1994	Mileage (km):	278176
Displacement (cc):	2500	Transmission:	AT
Color:	D GREEN	Model code:	JZX90
Result:	available	Auction grade:	R
Problem type:	Collision	Problem scale:	Repaired
Contaminated:	No	Airbag:	ОК
