## VEHICLE DETAILS

**Chassis number <sup>1</sup>:** PG6SA-102145

**Model:** AUTOZAM AZ-1

## ACCIDENT / REPAIR HISTORY

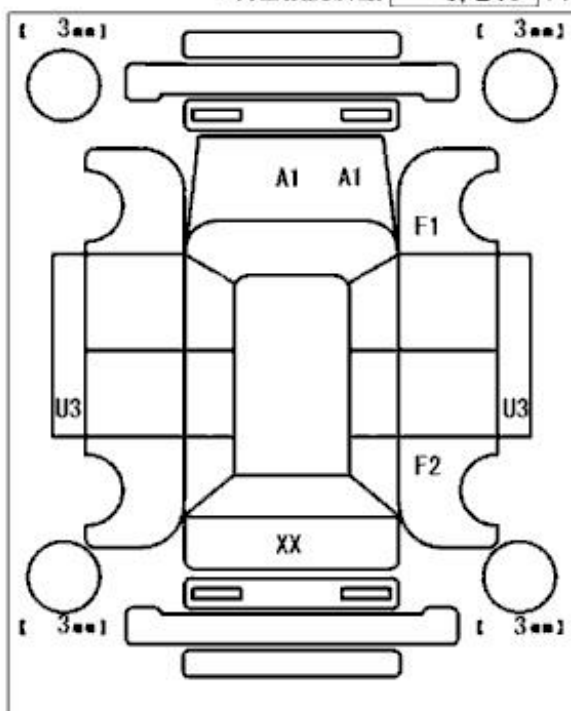
**メーター改ざん車**

◎走行に関する補足事項  
メーター改ざん

左Rサイドメンバー歪 右Rサイドメンバー歪小  
バックル XX 車内 各所外品取付  
下廻り A・U 各所下廻り S  
社外足廻り 社外マフラー  
社外アルミW 追加メーター  
外装 A・U  
Fガラストビ石  
室内ヨゴレ  
シートへたり  
ハンドルグリップスレ不良
