VEHICLE DETAILS

Make: SUZUKI

Model: CAPPUCCINO

ACCIDENT / REPAIR HISTORY

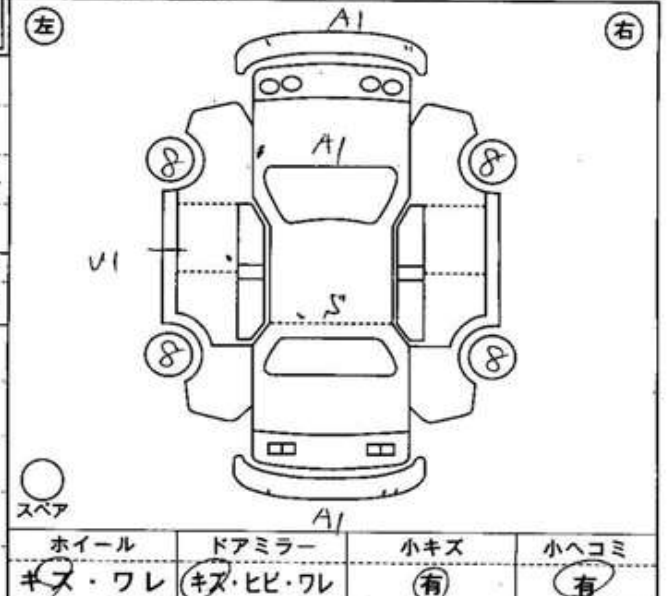
出品番号 34116	型式 E-EA11R	排気量 660 CC	車歴 自家用・レンタ	評価点 R改
	初年度登録 5/ 月	車名 カプチーノ	ドア形状 2WD

出品店記入注意事項	★ AAデビュー!! ★ CDデッキ ★ タコ足		
	★ ハートランド製エアロ ★ オーバーフェンダー		
	★ 社外メーター ★ クイックシフト ★ 社外インタークーラー		
	※ 取扱書・仕様書 後日発送		
検査員記入	内装	シート	オーディオ
	ウズ汚れ・汚れ	コゲ・キズ	スレ・コゲ・穴・キレ・シミ
	Fサイドメンバー	歪み	
	エアサポート	××	
	外ターボ	改	
	ギーストコントローラー	取付	改

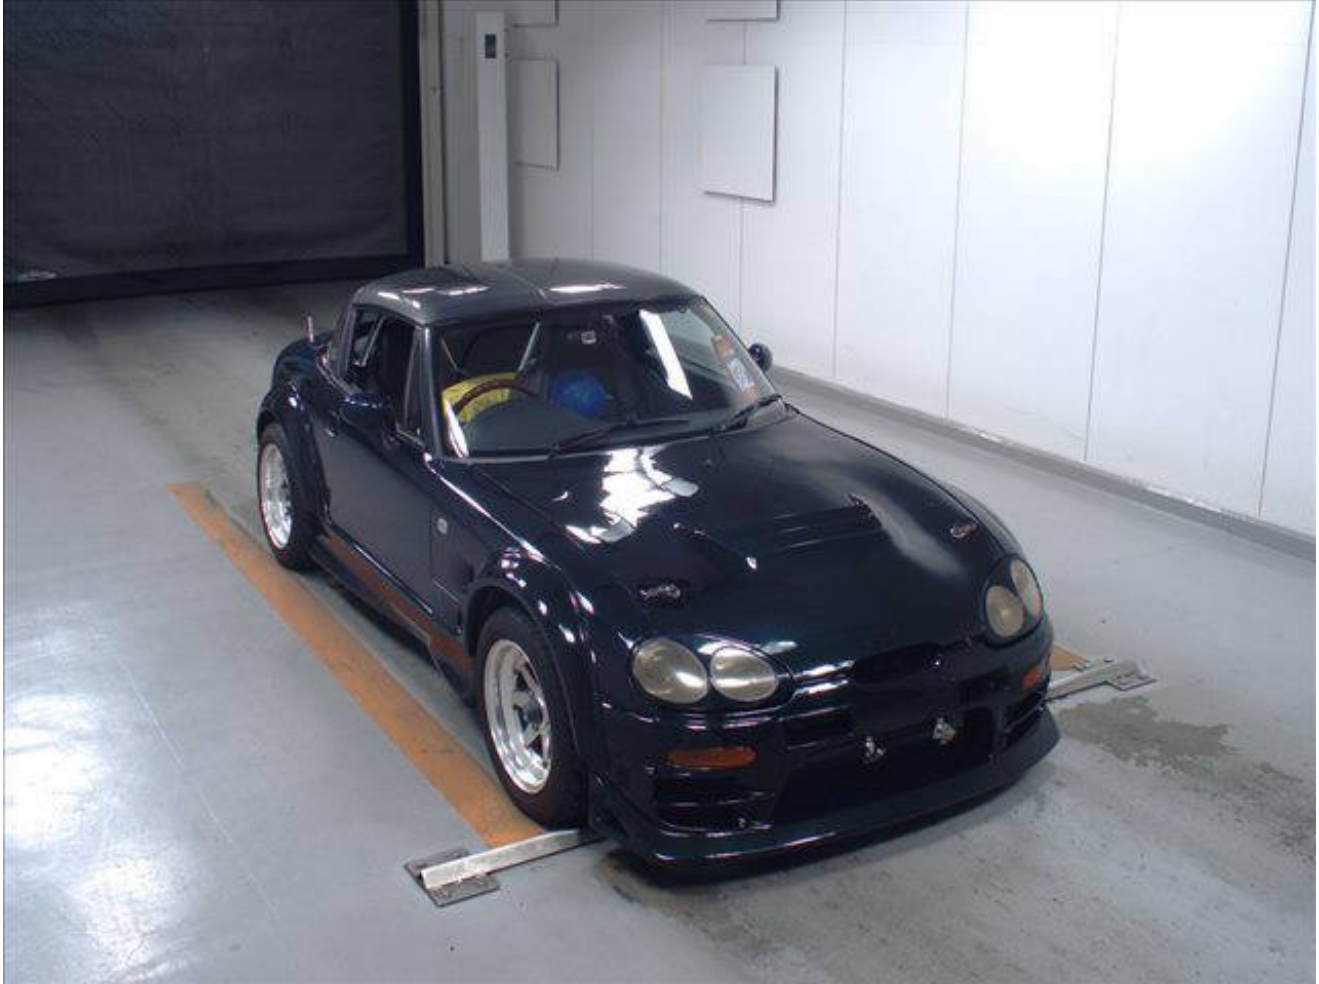
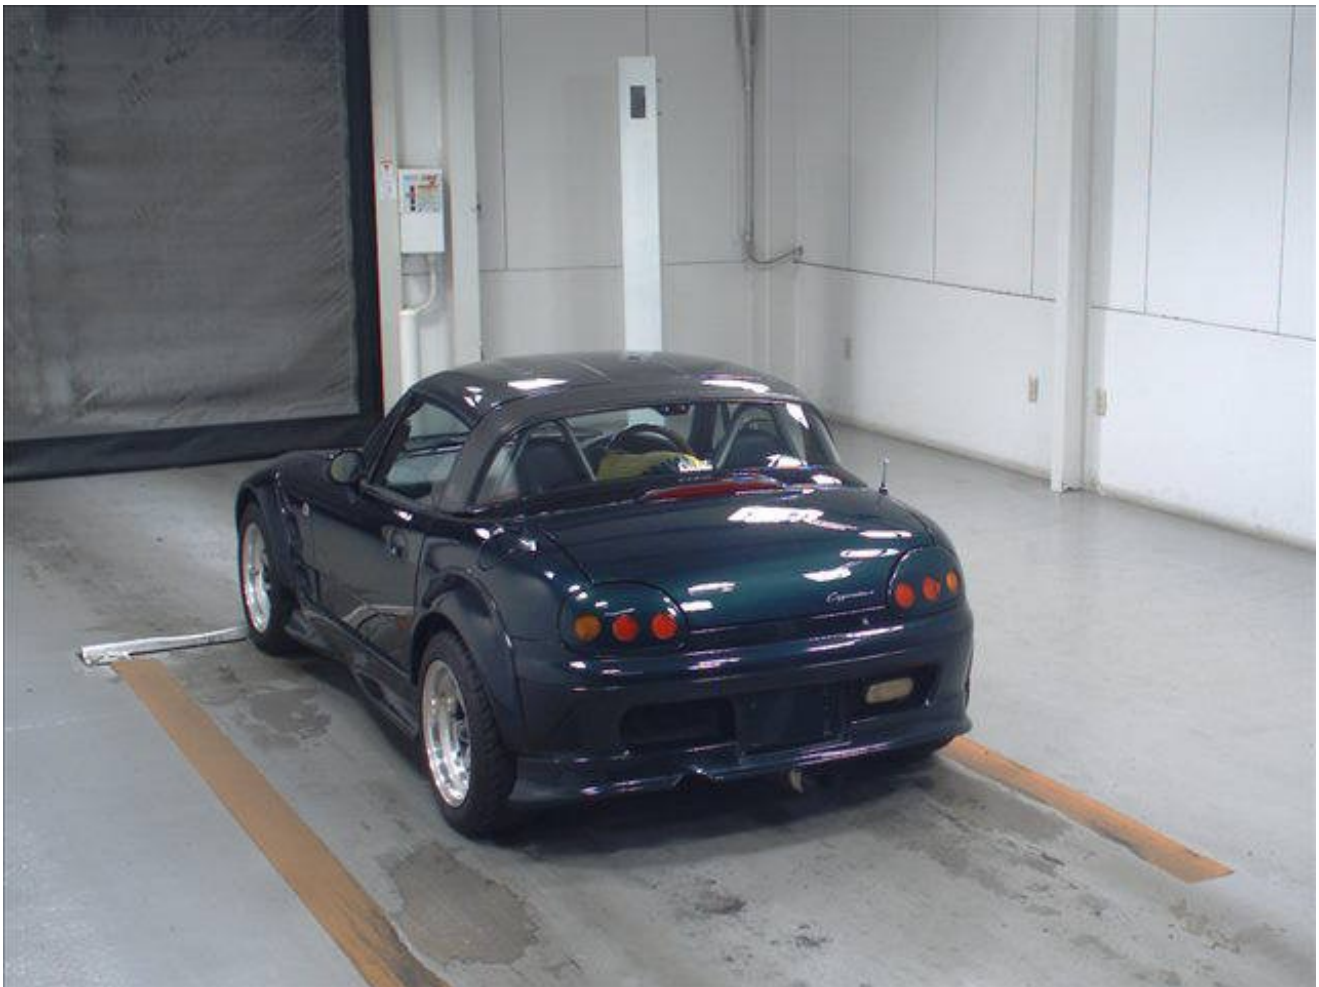
65010	車種 (自家用以外は記入)	排気量	型式	評価点 3.5
		660cc	E-EA11R	
	初年度登録年月	車名	グレード	2WD 4WD
	45/月	カプチーノ	2 ベースグレード	内装 B

車検	年	月	ソフト	5F	修正	S R	純AW	P S	P W
走行	16,697	(km)	冷房	AC	セルスポイント	カウ	TV	ナビ	エアB
外色	ダクソン	色	カラー	有・無	★初出品 ★実走行1ststart!				
内装	オリーブ	色	オリーブ		★263馬力 カスタム車 ★767シフト				
燃料	ガソリン	種類	ガソリン		★ハートランド製 社外エアロ				
年式	輸入区分	ハンドル	名義変更		★ロンシャン社外エアロ				
ディーラー	並行	左・右	月	日	★社外ステアリング 社外V277				
リサイクル	6430	円	車庫	2	登録				
預託金			人		車台	EA11R-115728			
○注意事項 (修理・不具合等および状態等)					シリアル

※作動確認済が、改造多数あり、現車確認下さい
 ★本車F.63+10. R70, ★本車シートジョイント製 FRP, ★本車リアゲートアサスト製, ★本車HKS製アルミ
 ★本車ハミル, シフト ★本車モーター設計・挿入設計
 ★本車製キャブ ★本車製ステアリング・V277

○検査員報告 (USS使用欄)
 ★本車に於ける★本車エンジン・707, 全56馬力・58馬力
 ★本車に於ける★本車エンジン・CST 車番58馬力 本車に於ける
