VEHICLE DETAILS

Chassis number ¹: LN130-0093027

Make: TOYOTA

Model: HILUX SURF

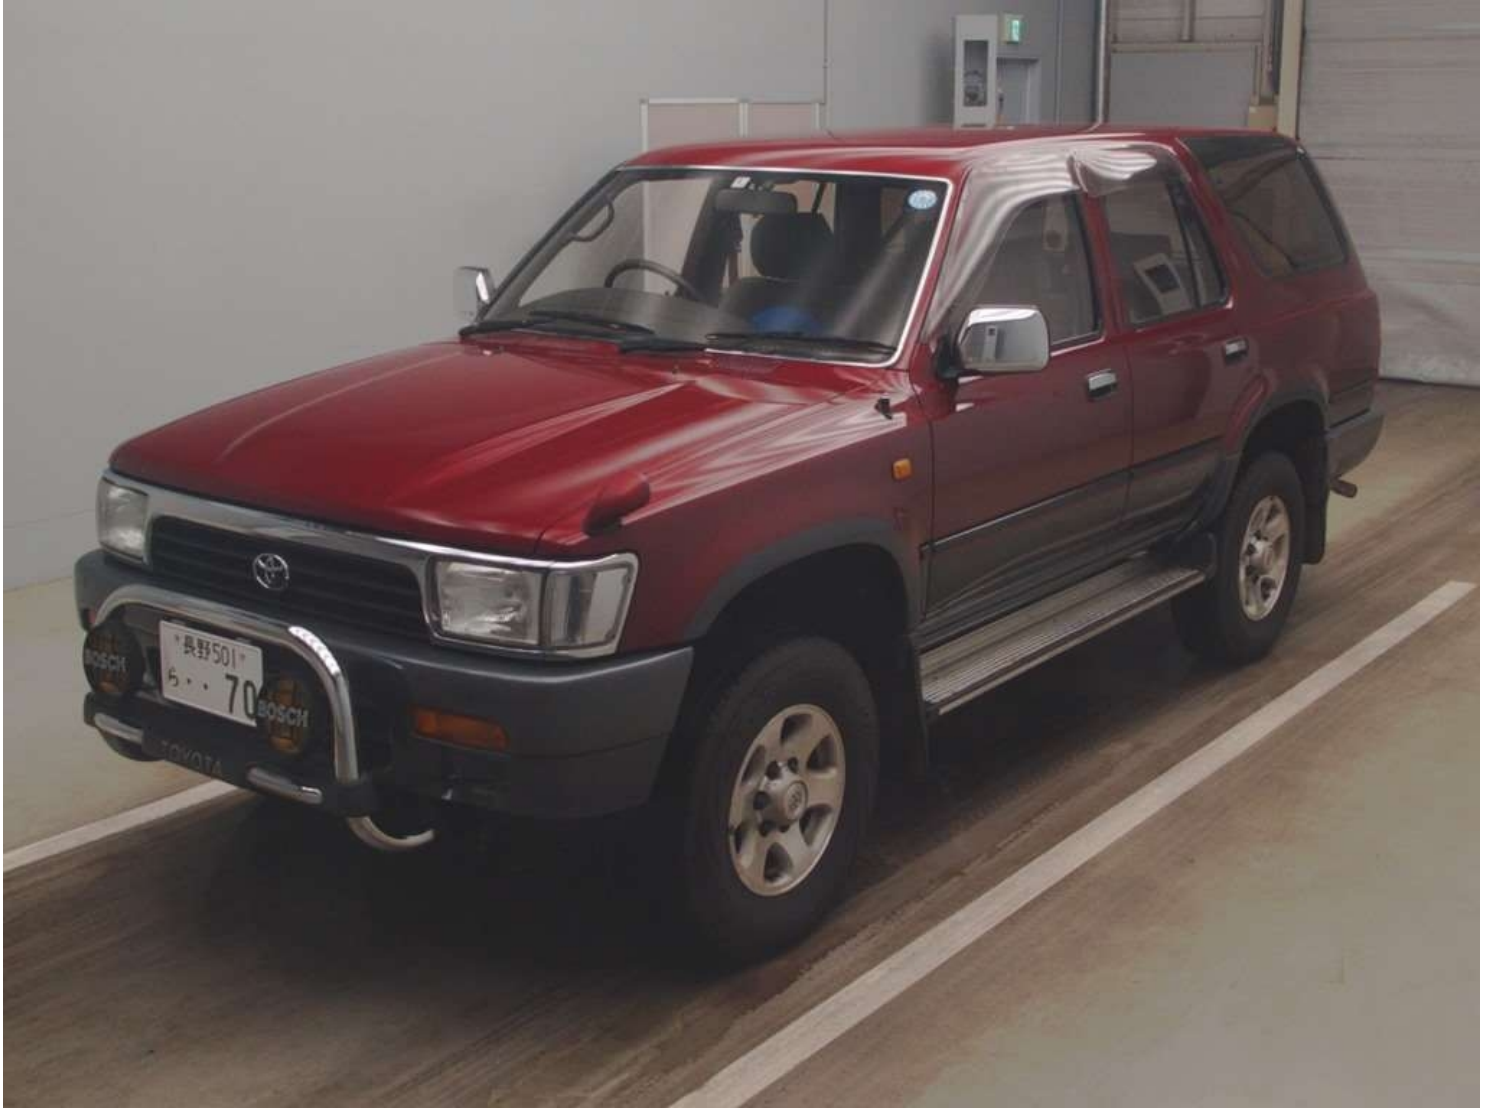
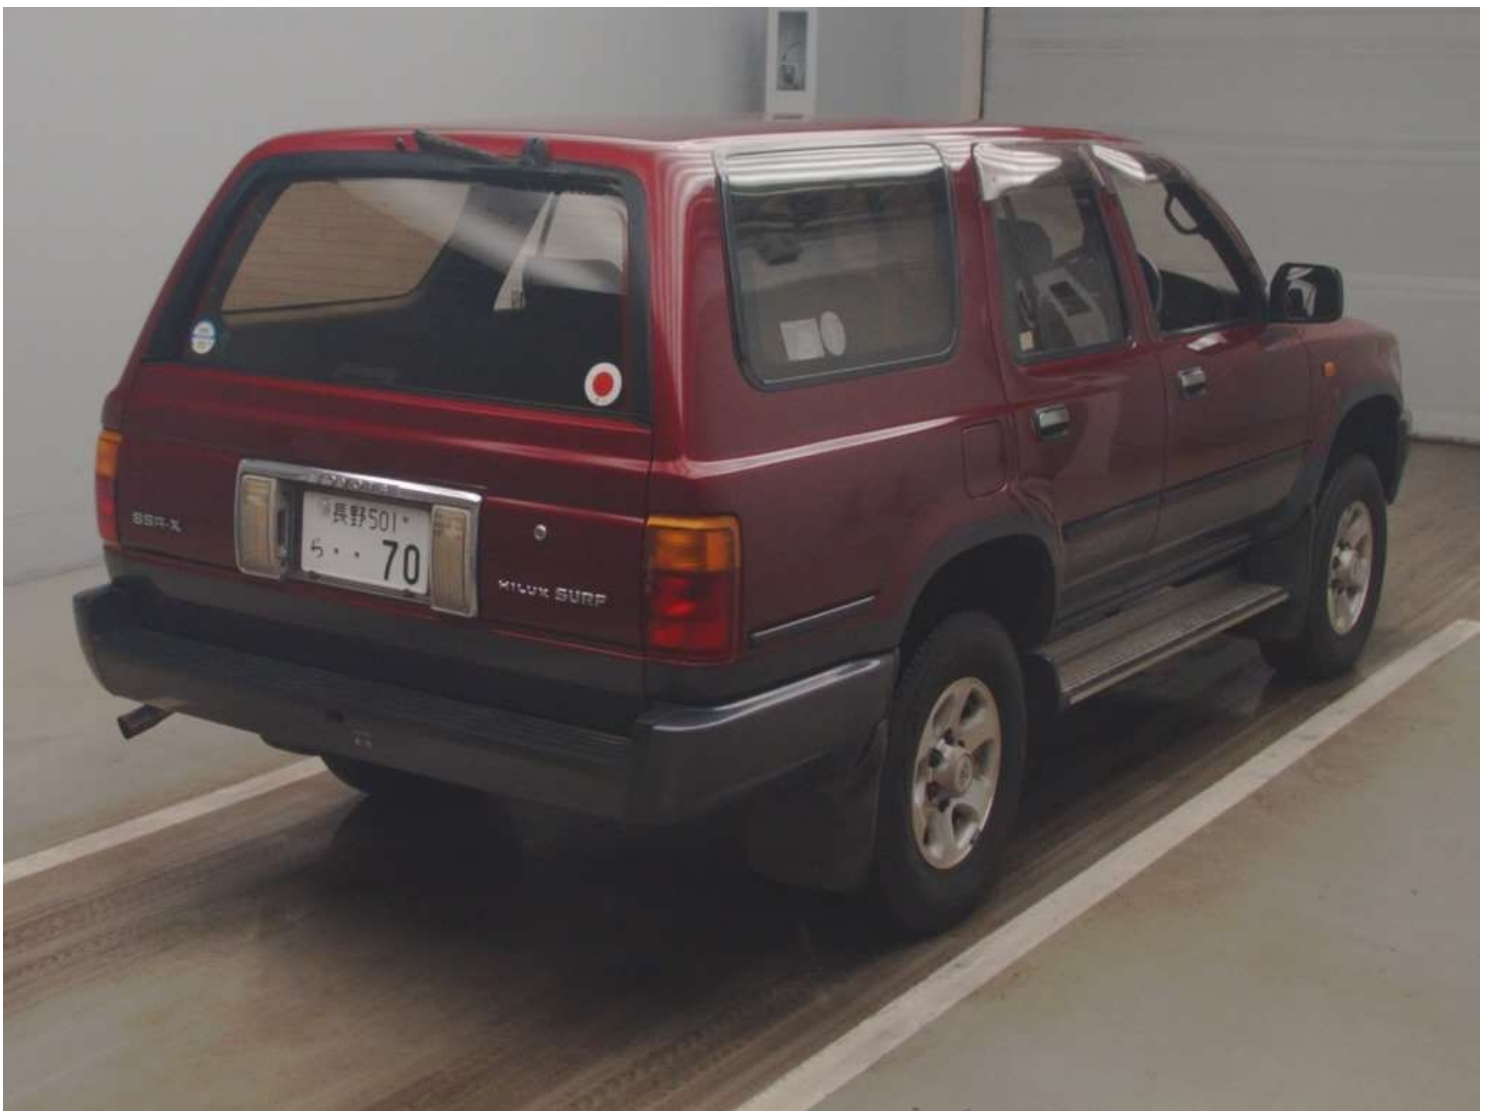
初年度登録 4 年 1 月	車名 ハイラックスサーフ			ドア・形状 5・W	グレード SSR-X 4WD			駆動 4WD	総合評価点 R 修復歴有
型式 Q LN130G	排気量 2,400 CC	燃料 軽油	車歴 自家用	定員(最大) 5 名	積載量(最大) Kg	輸入車 年行'A			
ミッション F5	エアコン AC	カラーNo. 25T	外装色 ウイングレーズトーン	装備 PS PW	アルミ		保証書 取説	内装評価 C	
走行距離 90,416 km	車検 5 年 1 月	登録ナンバー 長野501ら 70	ほか装備	車台番号 LN130-0093027		預託金 7,050 円

セールスポイント	特記事項・不具合箇所
	RインナーW 腐蝕車 下廻りC 外装しみ エンジンルームS 外装うすい線キズ ハンドルすれ シートへたり 室内薄汚れ ドア内張傷小 ピラー内張傷小
注意事項
