VEHICLE DETAILS

Chassis number ¹: EA21R-102070

Make: SUZUKI

Model: CAPPUCCINO

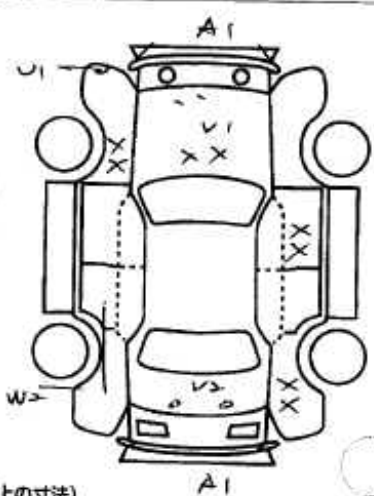
◎注意事項 (修復・不具合箇所および状態等)
 純正 マフラー・エアフィルター 定期的交換
 ターボタイマー 5/9 2799-!
 ローダウン? 社外ハンドル、17"
 フロント封

◎検査員報告 R修復
 カパキウス汚レ
 石キマターXX
 パワウィプル) 修理
 トランフフロア)
 各取白のシツ

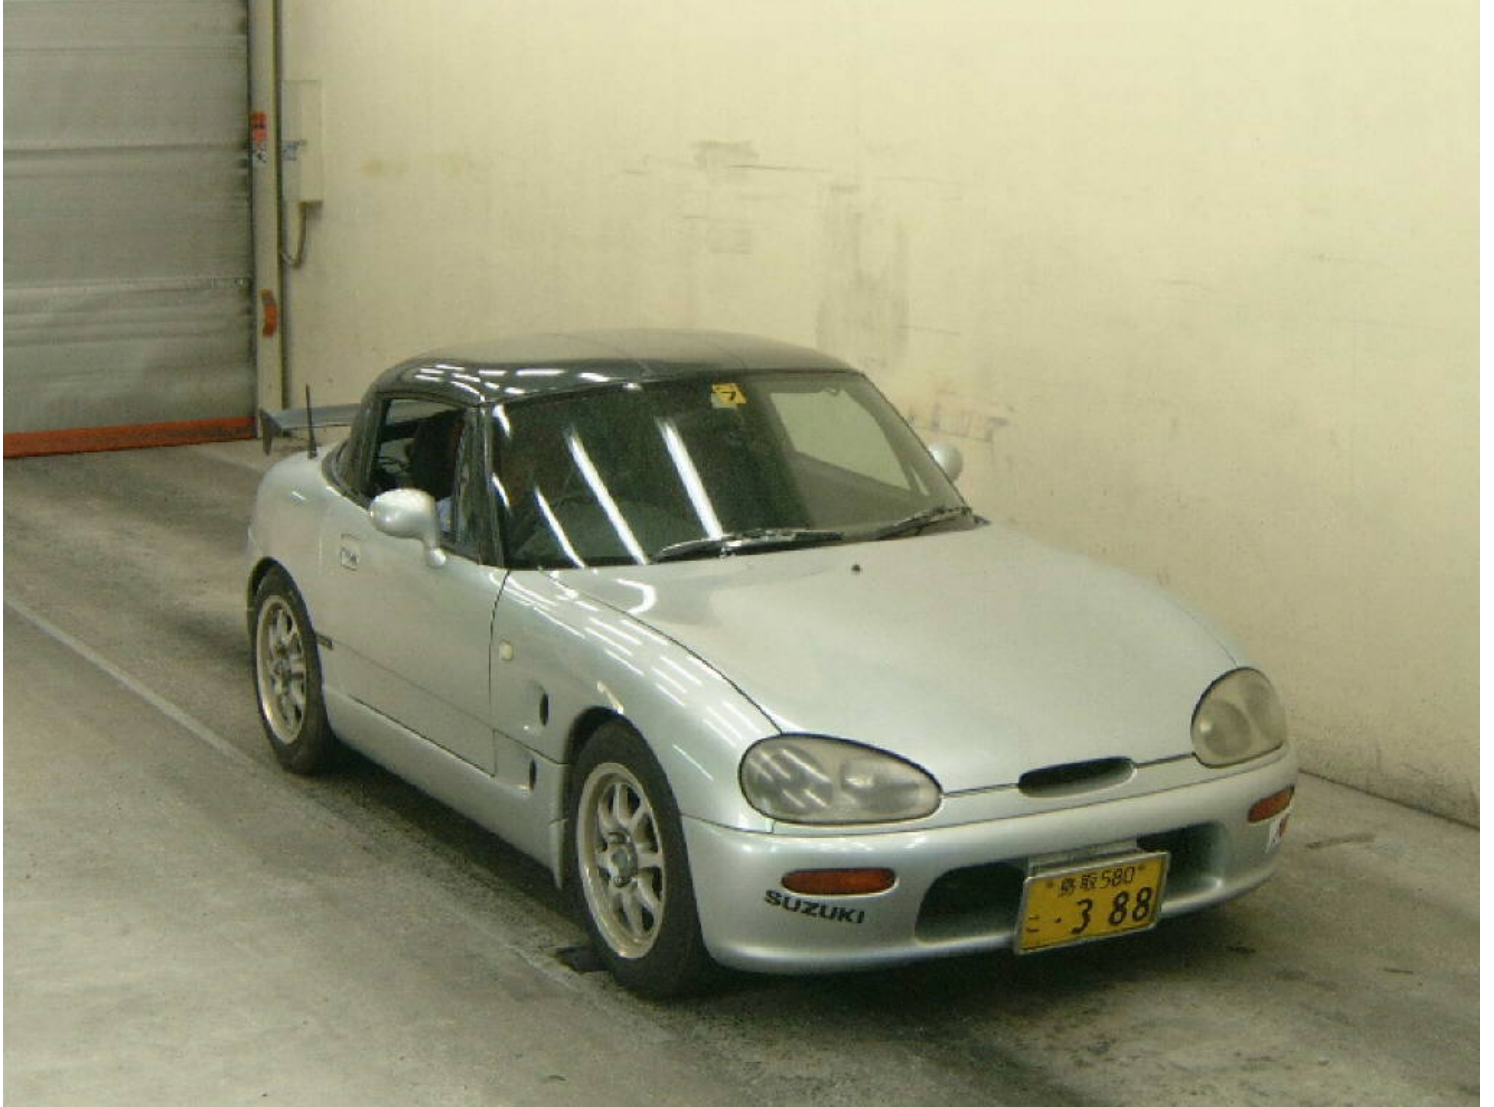
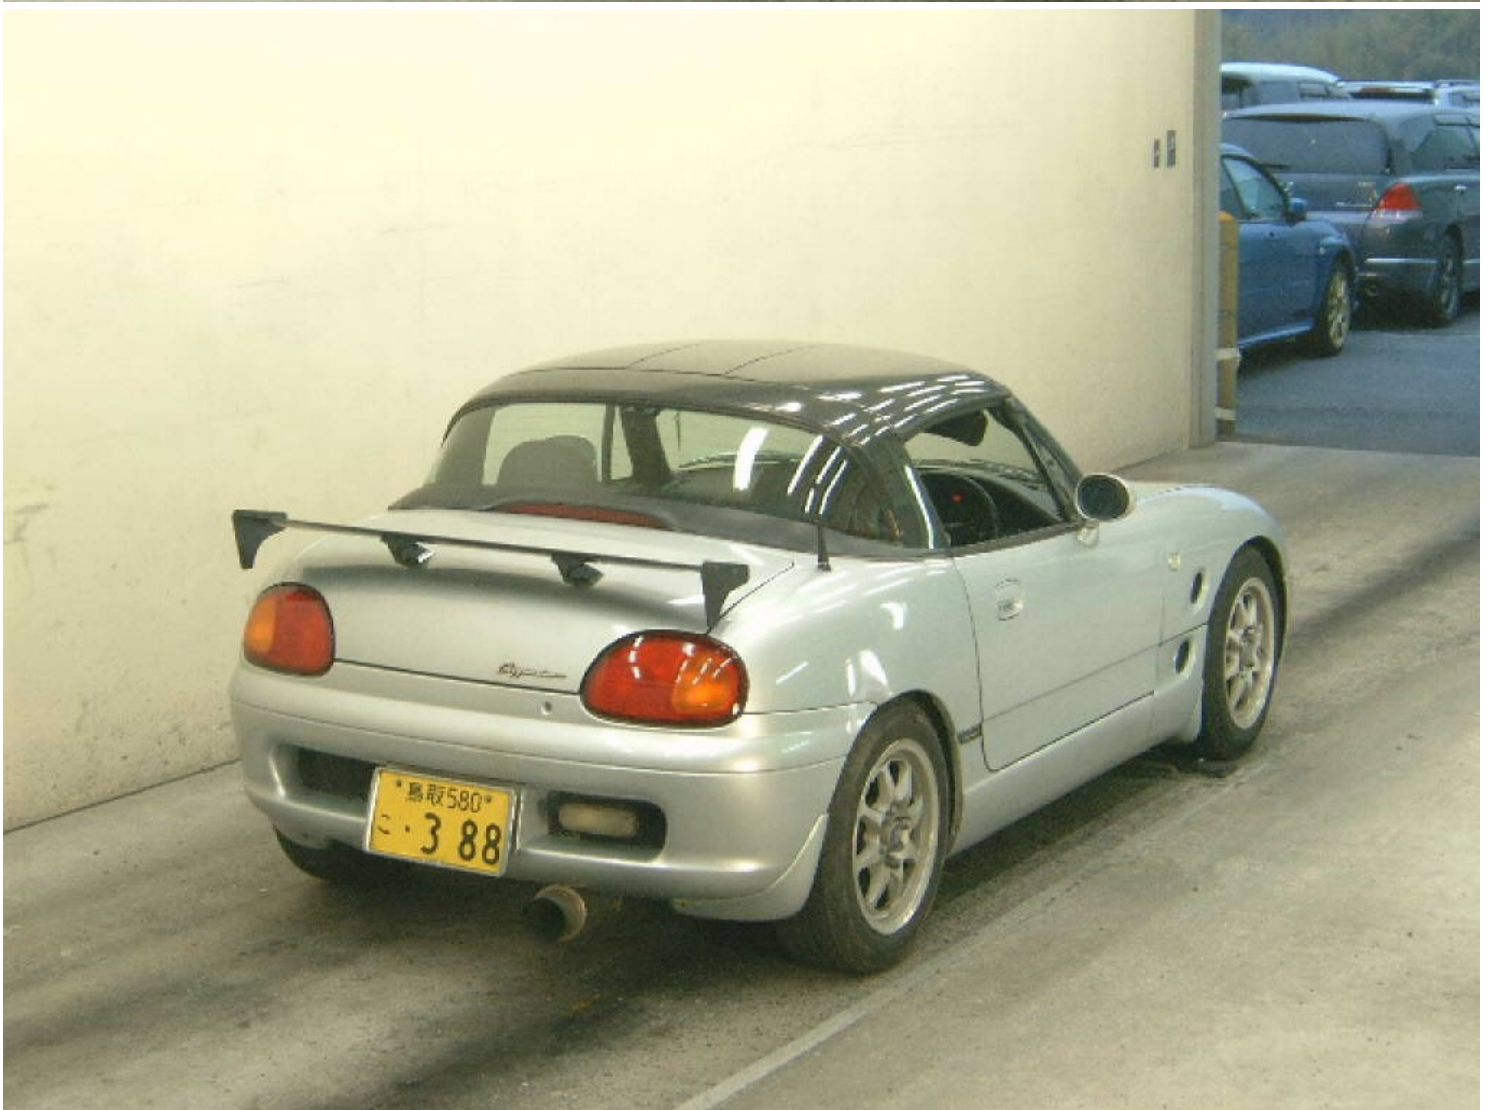
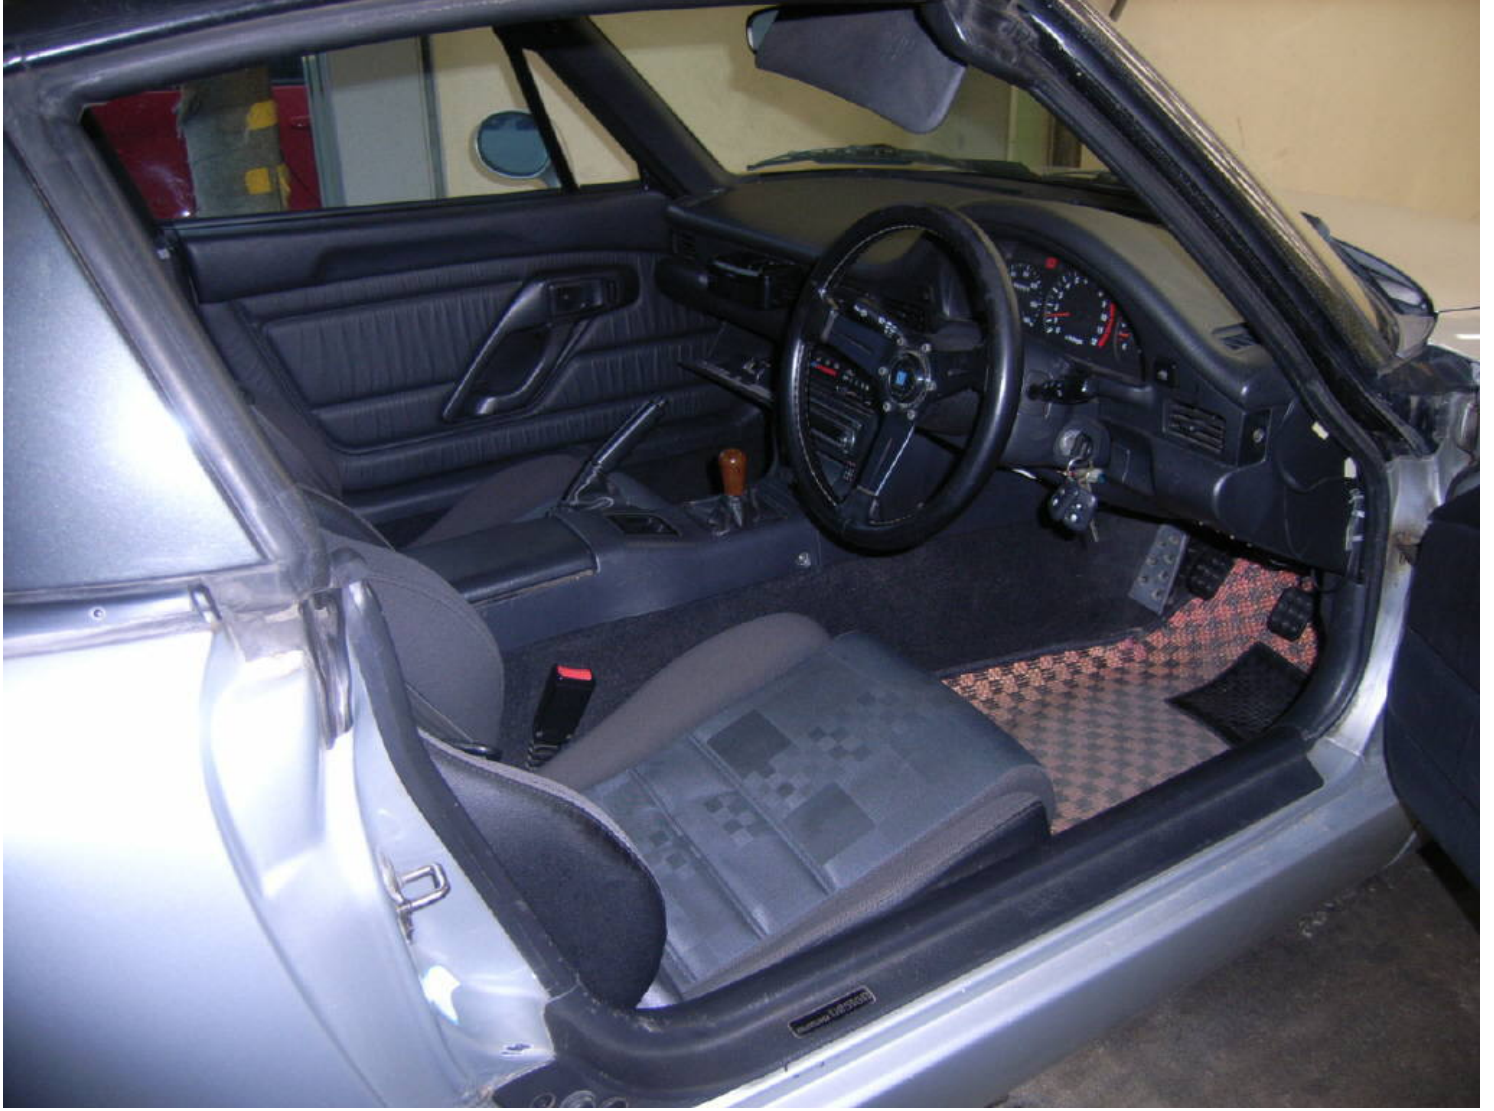
314	車種 (軽乗用車以外は記入) 排気量	型式	評価点
	660	E-EA21R	R
初年度登録年月	車名	グレード	2WD
8/月	カーナーノ	2	4WD
			内装 C

車検	4年	12/27月	シフト	F5	特選	S R M A W	PS PW
走行	105,960	マイル	冷房	AC	セールスポイント	カワ TV ナビ	IFB
外色	シルバー	色	有・無	有・無	車高調, ETC		
内装	IVN	カラー	有・無	有・無	5F. ターボ		
燃料	ガソリン	エンジン	名義変更期間		社外スタンプ		
輸入国	ディーラー	走行	左・右	月	日

リサイクル	5950	円	登録料		登録料	大宮	5814	27
税金						車台	102070	
注意事項 (軽乗用車以外は記入)			シリアル

トヨタLJ-9-150R, 社外品あり
 2012年4月 80,700kmメーター (社外品あり)
 2007年 102,000kmメーター (社外品あり)
 X-9-改換車
 ○検査員報告 (USS使用) 各修正
 右PW不良 外品有 各修正済み
 センソール等が脱落し加圧不足
 シートスリット等 外品有各修正済み
 右Fピラー 修正済み 左右RピラーXX
 両Rピラー 修正済み
 フアサポート 修正済み 左Fサポート先部
 Fサポート 修正済み R707BF修正
 [荷台内寸] 長さ x 幅 x 高さ (cm)
 長さ 幅 高さ (車体上の寸法) スペア
