## VEHICLE DETAILS

**Chassis number <sup>1</sup>:** PG6SA-102145

**Model:** AUTOZAM AZ-1

## ACCIDENT / REPAIR HISTORY

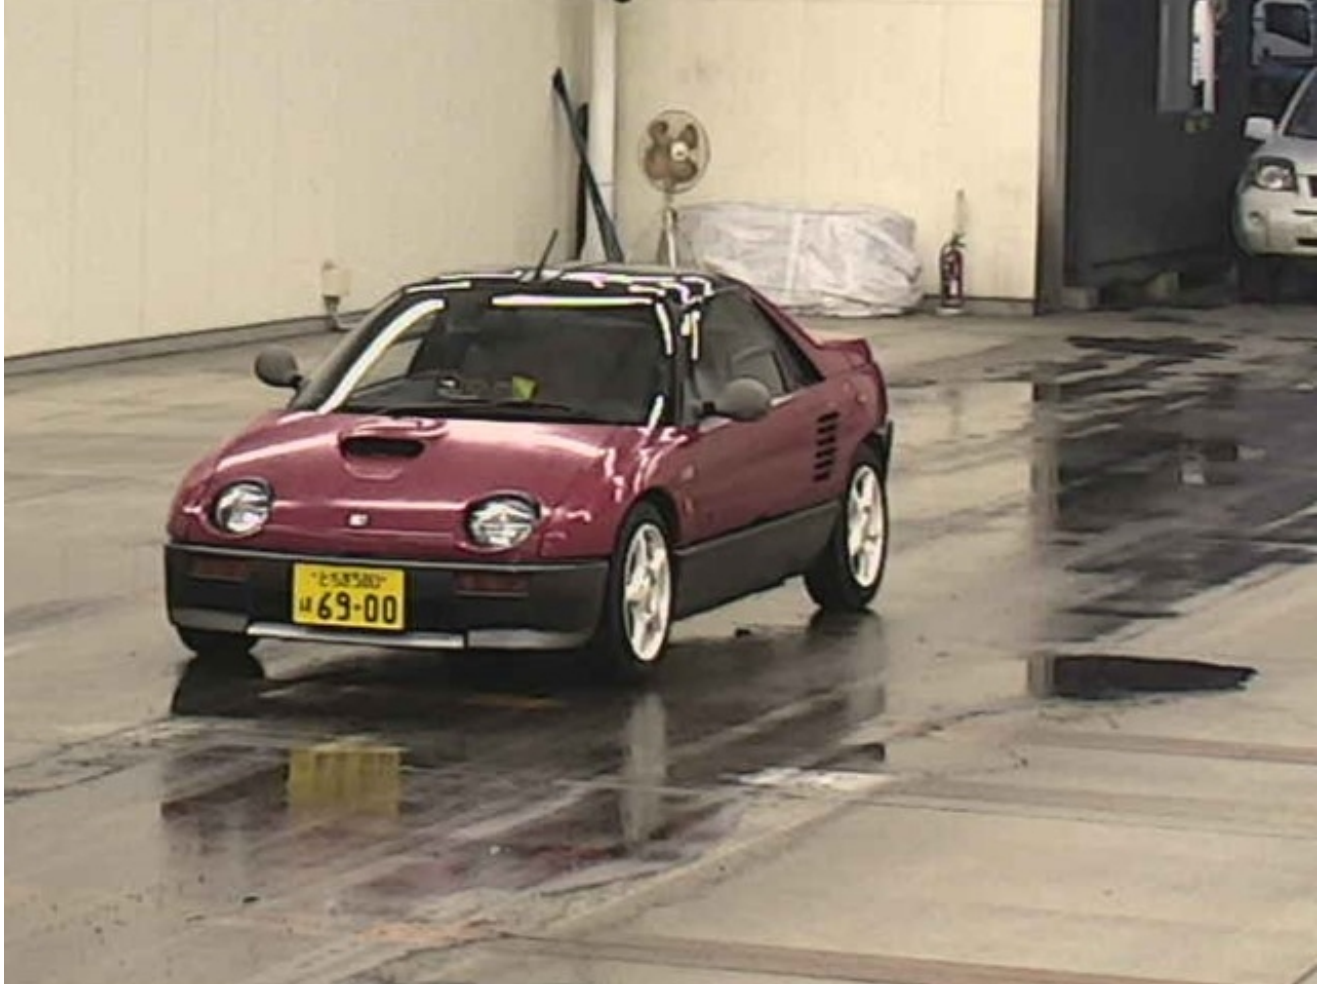
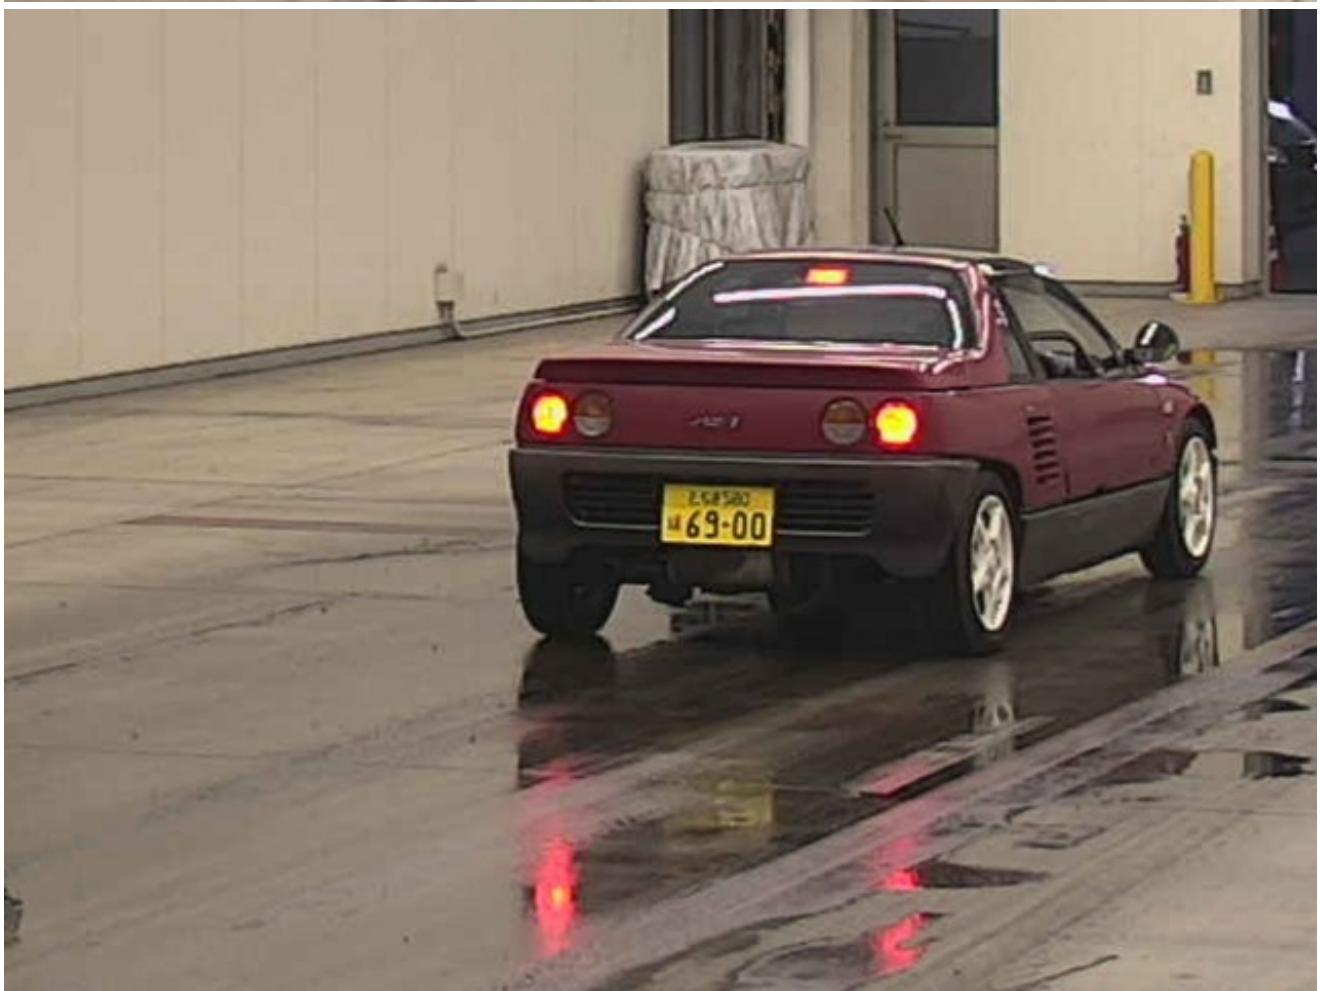
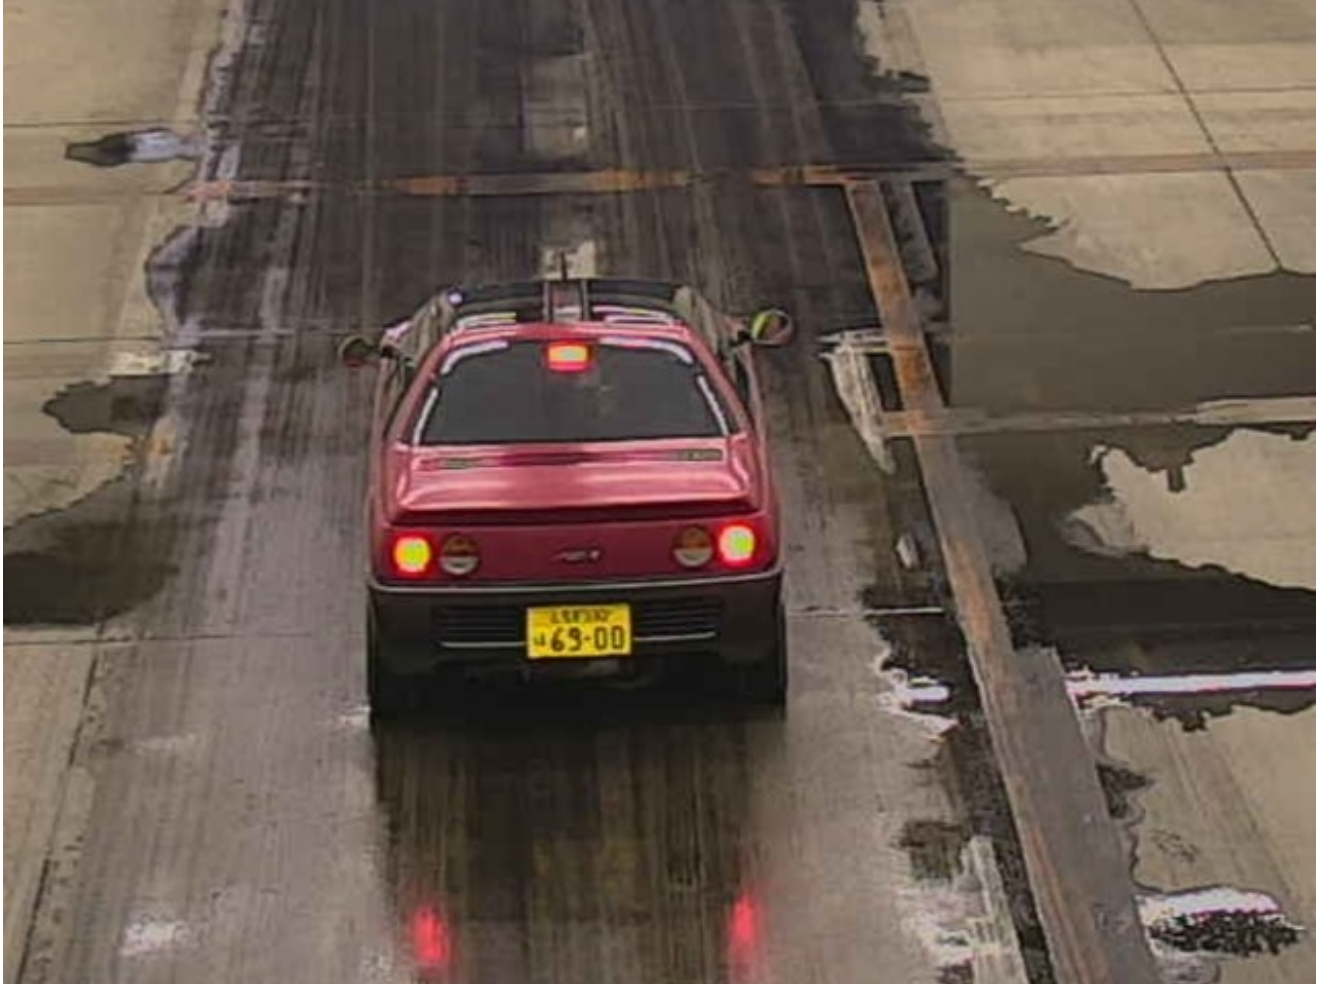
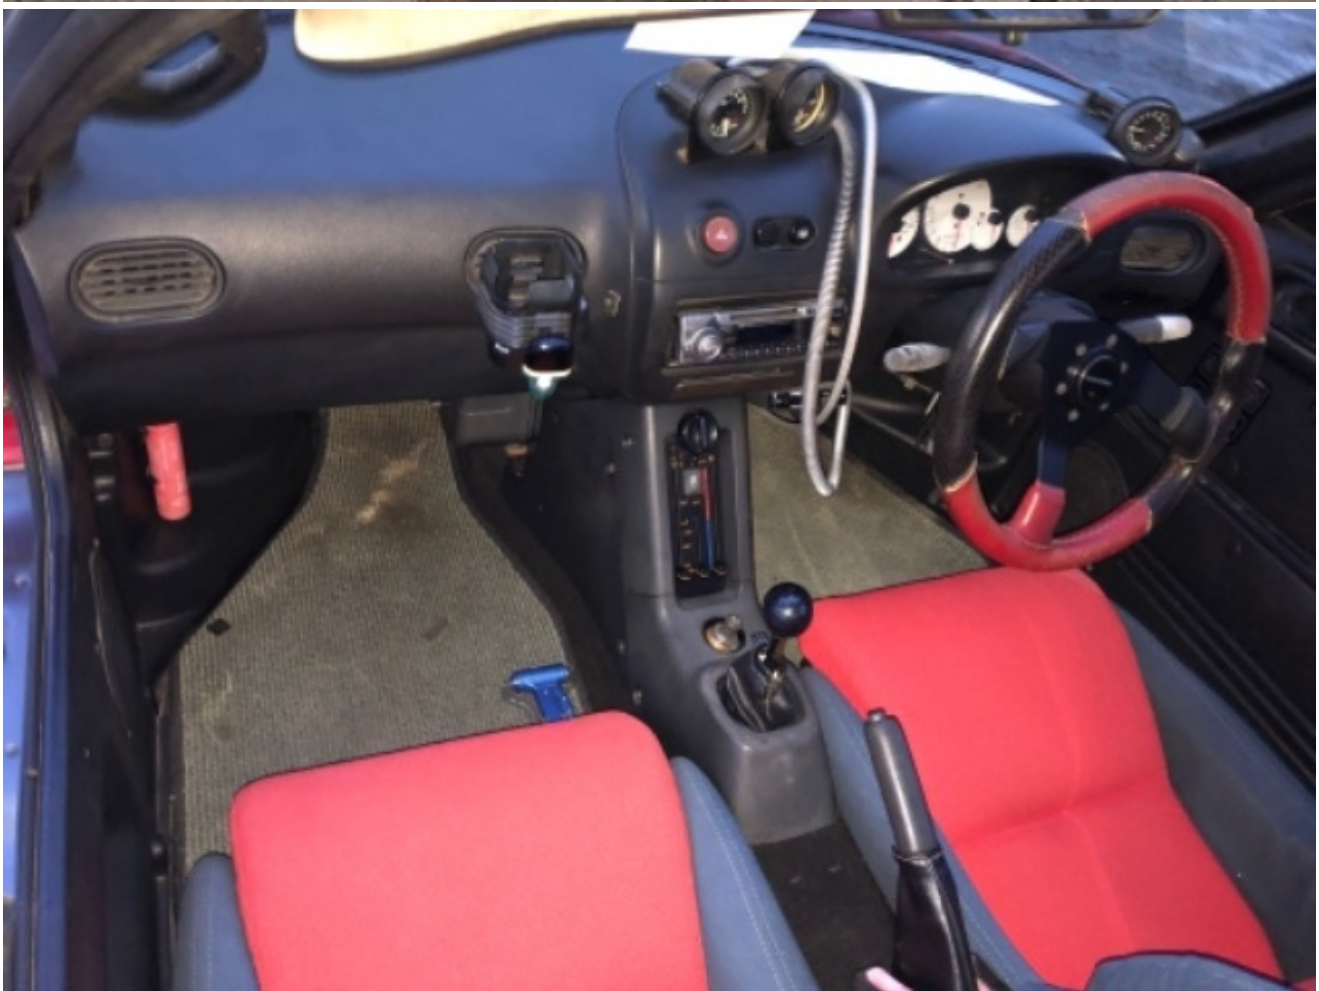
車台 No. PG6SA-102145

Reported				
—	—	2022-05-28	ARAI Oyama VT	Repaired	OK
Malfunction
